# An Experimental Study of the Behaviour of Small Vessels When Run Down

Barry Deakin

Wolfson Unit MTIA, University of Southampton.  
Southampton, UK

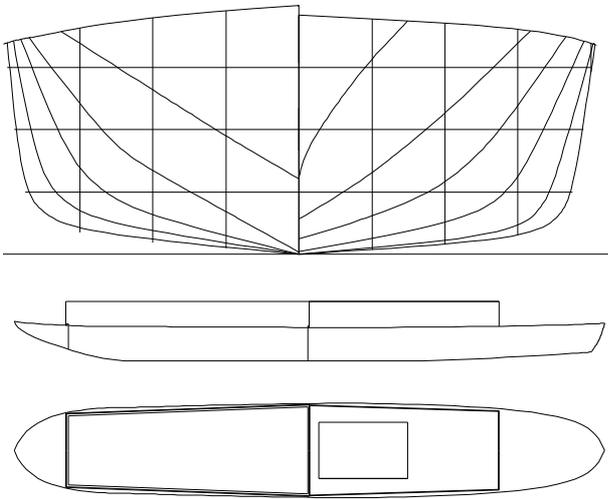
Fig. 1. Marchioness model

Principal dimensions of the vessel are presented in Table 1, drawings in Fig. 1 to Fig. 3, and the stability characteristics in Fig. 4 to Fig. 6.

A model hull was constructed, at a scale of 1:16, of wood strip planks on frames, sheathed with GRP inside and out. It included the skeg and rudder but no other appendages. One level of superstructure was constructed in two modules, fore and aft, with an open top allowing downflooding at any point along its perimeter. The Marchioness was partially decked, with an undecked compartment extending through most of the aft part of the vessel with a very low coaming to the window height. This characteristic results in a low angle of downflooding, giving an effective range of stability

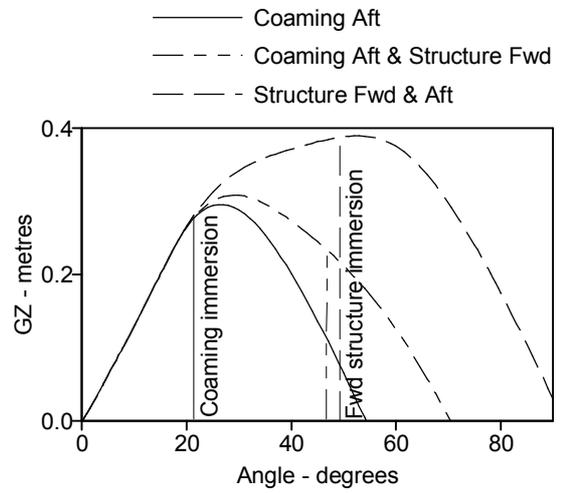
Fig. 4. Stability of the Marchioness model

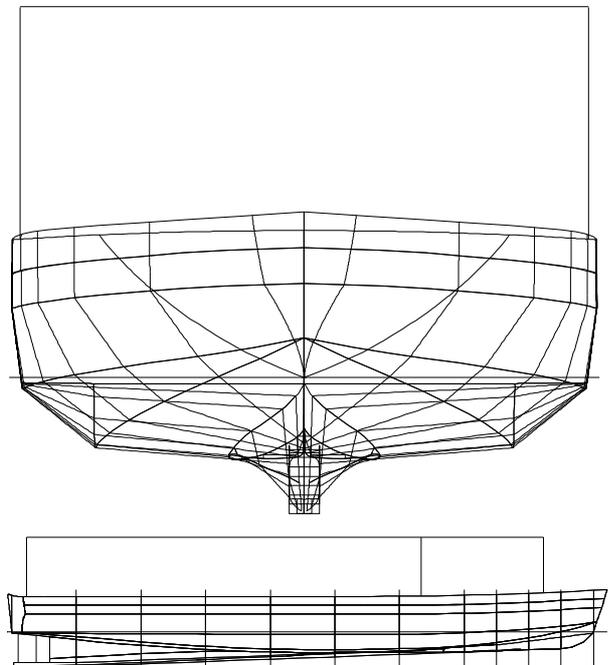
Fig. 2. Wider vessel model

The model was constructed, at a scale of 1:16, of wood strip planks on frames, sheathed with GRP inside and out. It was fully decked and a simple open topped superstructure was constructed to represent the first level of accommodation on the full scale vessel.

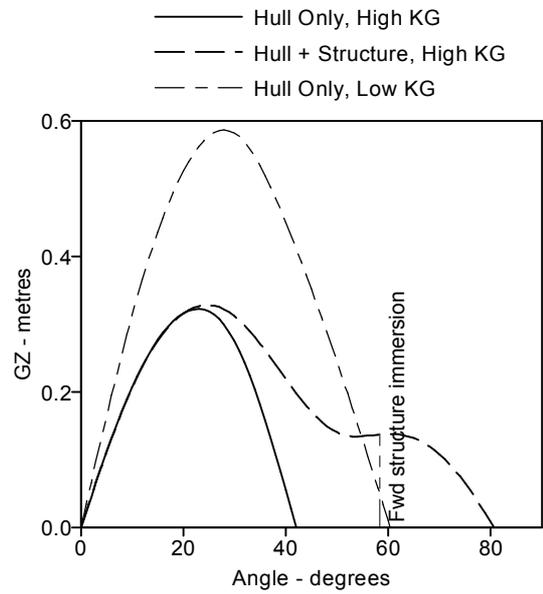
Fig. 5. Stability of the wider vessel model

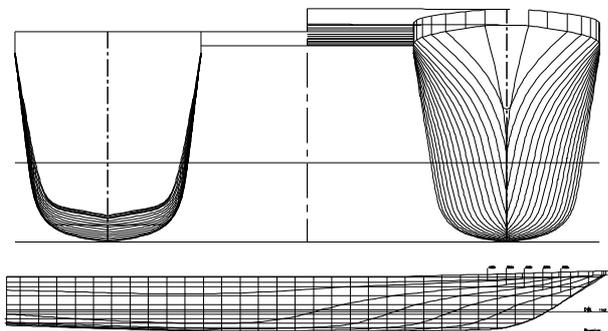
Fig. 3. Catamaran model

The model was constructed, at a scale of 1:20, of GRP and Kevlar. It comprised the two symmetric, round bilge hulls, and a flat bridge deck. No appendages or superstructures were fitted.

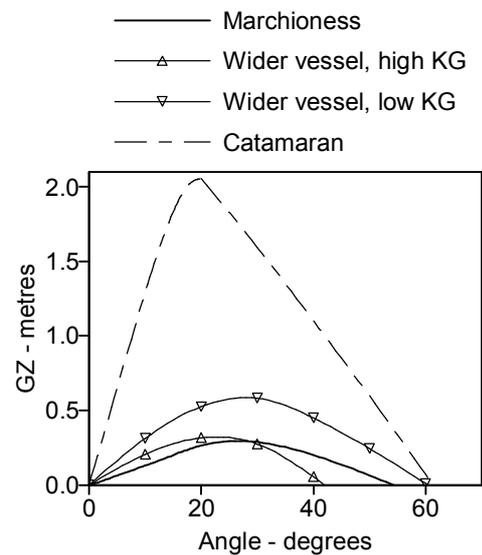
Fig. 6. Comparison of the stability of the three models without superstructures

Comparison of the stability curves reveals some common characteristics and some highly variable ones. For example, the Marchioness and the wider vessel with a high KG have similar maximum values of GZ, while the catamaran has a much larger value. The wider vessel with the low KG has a similar range of stability to the catamaran but still with a much lower maximum KG. It was hoped that these selective differences would assist in the identification of the most influential characteristics. A summary of the stability characteristics is presented in Table 2.

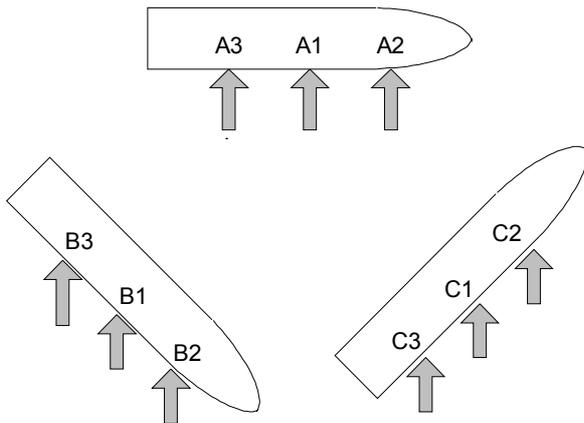
Fig. 7. Notation used to define the collisions

The behaviour of the models was very dependent on the longitudinal location of the impact and the orientation of the model relative to the course of the colliding vessel, or strut. To simplify discussion of this aspect a notation will be adopted as defined in Fig. 7.

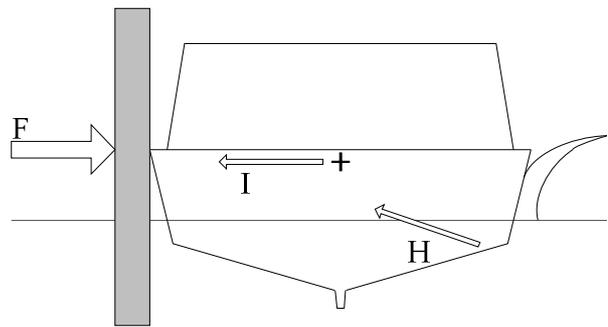
Fig. 8. Forces acting during the transient phase

In this phase it appeared that the model responded to three principal moments that governed its initial roll response. These are illustrated in Fig. 8.

The force, denoted F, of the strut applied to the side of the model and the height at which this force is applied. The height is at the point of impact and therefore is dependent on the section shape of the hull and superstructure, and the shape of the stem of the colliding vessel.

The reactive inertial force, I, due to the acceleration of the model in the direction of travel of the strut, acting at the centre of gravity. The height at which this force acts is dependent on the height of the centre of gravity.

The reactive force, H, due to the water resisting movement of the model, acting through the centre of pressure. On impact, the water alongside the vessel, on the opposite side to the impact, is displaced under pressure resulting in generation of a wave along the topsides. This may be likened to the response to a slam, and is similar in appearance to the spray sheet on the hull of a planing boat.

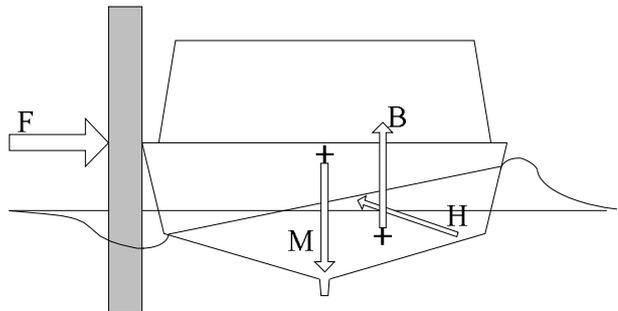
Fig. 9. Forces acting during the quasi-static phase

Once the passive vessel has been accelerated to the speed of the colliding vessel, the inertial force associated with the acceleration is reduced to zero, and the flow around the hull becomes steadier. A wave pattern is set up around the hull as illustrated in Fig. 9.

On the pressure side a wave crest is formed and on the suction side a wave trough, so that the vessel floats on an inclined water surface. Its hydrostatic stability on this inclined surface generates a roll moment towards the colliding vessel because of the transverse displacement of the centre of buoyancy from the centreline.

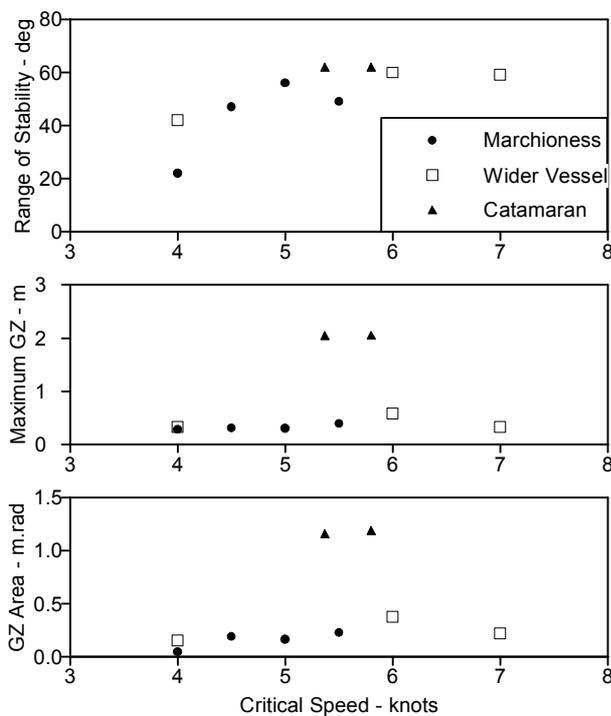
Fig. 10. Variation of critical speed with stability

This finding is less clear however, when all of the test configurations are studied together. Fig. 10 presents three plots of the critical capsize speeds for each configuration against the range of stability, the maximum GZ and the GZ curve area. Although there are some indications of trends, particularly with respect to range of stability, the data do not enable reliable trend lines to be defined.

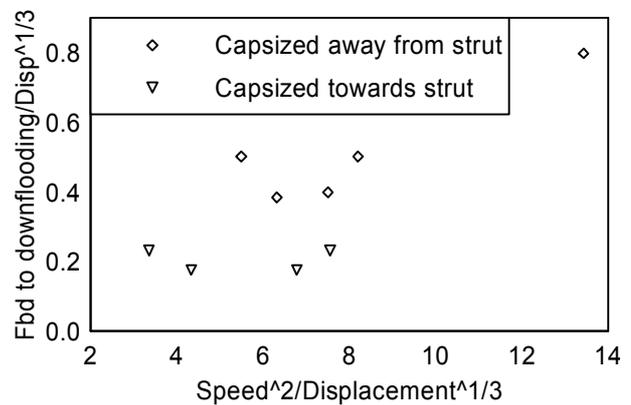
Fig. 11. Variation of critical speed with freeboard

An example is presented in Fig. 11 to show a possible trend between freeboard and critical speed. Speed squared has been used because it is believed to be more representative of the forces involved, and both have been divided by the cube root of displacement so that the data are independent of vessel size. An interesting aspect highlighted by these data is that all of the cases with relatively low freeboard capsized towards the strut.

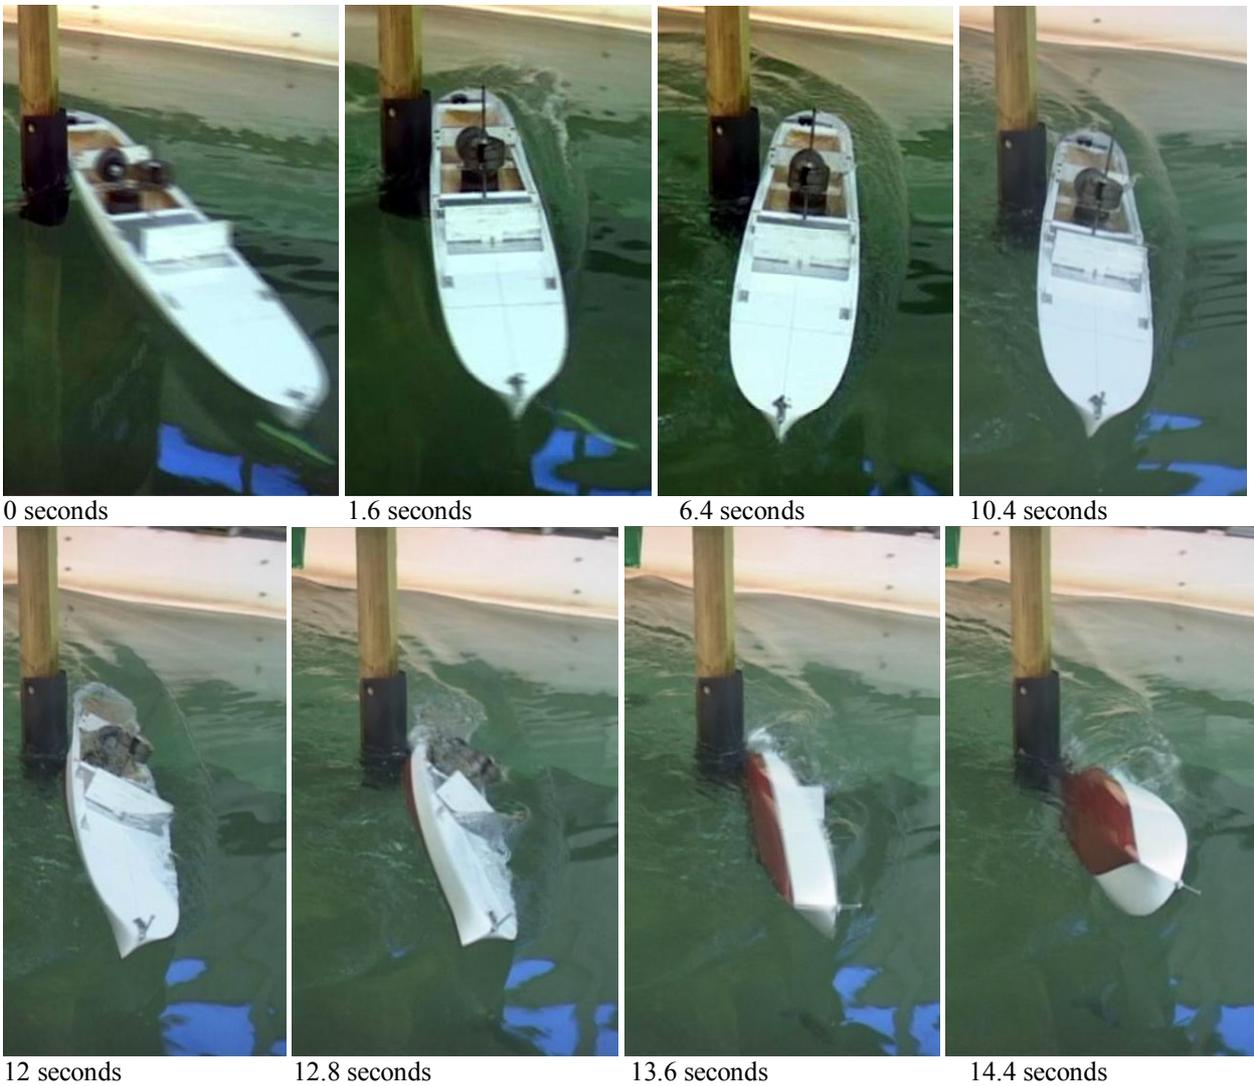
**Fig. 12. Simulation of the Marchioness incident. Collision speed 4.5 knots**

The sequence of images presented in Fig. 12 show a re-enactment of the collision between the Bowbelle and the Marchioness, within the limitations of the experimental method. For convenience, the collision in this sequence was to the starboard side, but otherwise is representative of the attitude and impact point described in the MAIB report. The model behaviour appears to correlate well with that reported for the incident at full scale, and is consistent with the fact that impact damage was sustained from the deck to the keel.

At 4 knots the model did not capsize but was pushed sideways, approximately upright. At 4.5 knots the model capsized as illustrated. The MAIB report states that the Bowbelle was making good about 5.5 knots against a 3 knot tide, while Marchioness was making good 3 knots, perhaps less. The course of Marchioness was at about 45 degrees across the bow of Bowbelle. In

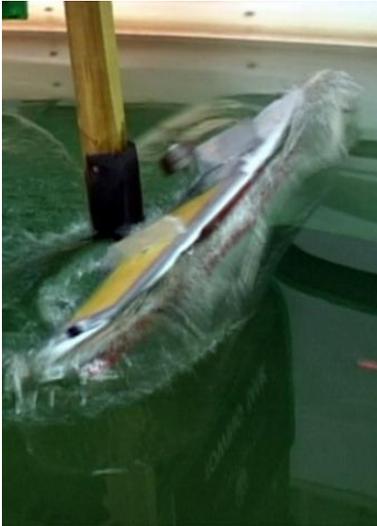
**Figure 13. Marchioness, decked, 6 knots, 1.6 seconds after impact**

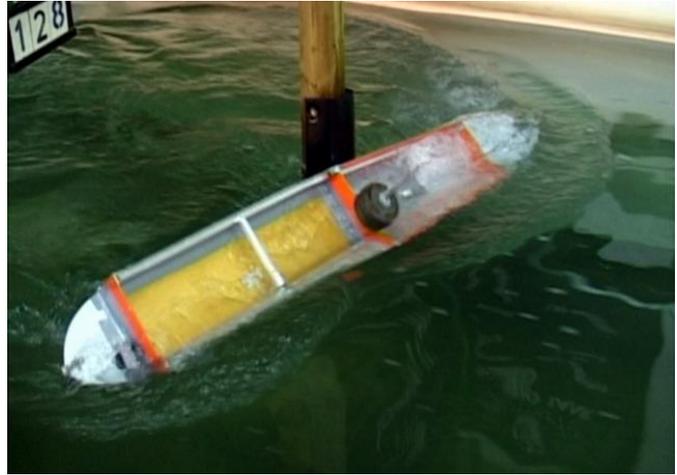
**Figure 14. Marchioness, with full superstructure, 5.5 knots, 6.4 seconds after impact**

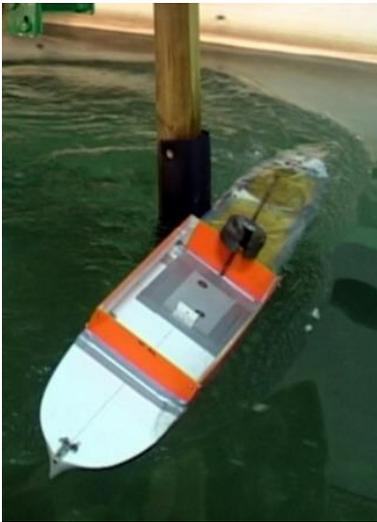
**Figure 15. Marchioness, with aft superstructure, 4.5 knots, 6.4 seconds after impact**

Impacts at different points along the hull result in different yaw rates, and these can have a strong influence on the behaviour, particularly in the quasi-static phase. When the Marchioness model was struck beam-on amidships (Figure 13) it was pushed sideways without yawing, and capsized very rapidly towards the strut. When struck aft of midships from the stern quarter, as was the case in the Marchioness incident and in Figure 15, it capsized away from the strut, after

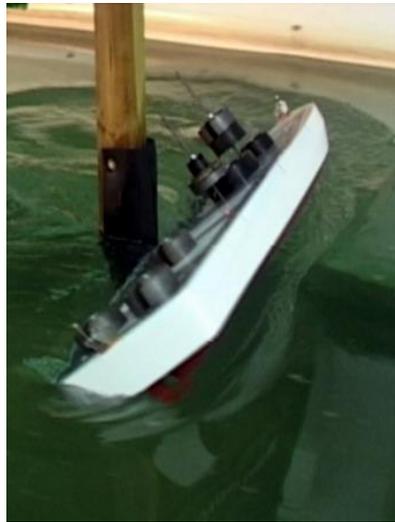
**Figure 16. Wider vessel, high VCG, 4 knots, 4.0 seconds after impact**

There is clear evidence from the tests that, for a given vessel configuration, increased stability provides increased resistance to capsize. Comparison of runs 88 and 121 for the wider vessel provides a good example, because the capsize mechanisms were observed to be

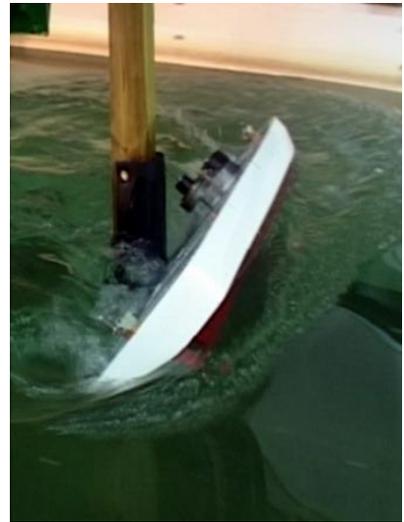
**Figure 17. Wider vessel, low VCG, 6.5 knots, 4.0 seconds after impact**

Figure 17 and Figure 18 show tests where the model rolled rapidly on impact towards and away from the strut respectively. The different behaviour is believed to result primarily from the presence of the superstructure.

the same (Figure 16 and Figure 17). Run 88 was with the lower stability condition, where the critical speed was 4.5 knots. Run 121 was with the higher stability condition and the critical speed was 6 knots. The difference between the test configurations is merely that ballast weights were relocated to reduce the height of the centre of gravity. The GM increased by 51%, the maximum GZ by 83%, and the range of stability by 43%.

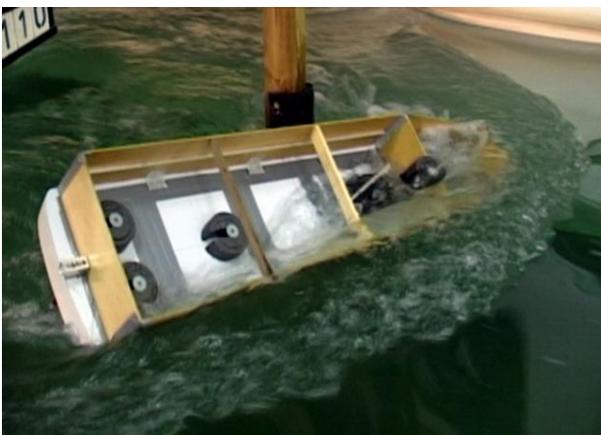
**Figure 18. Wider vessel, high VCG, with superstructure, 8 knots, 9.6 seconds after impact**

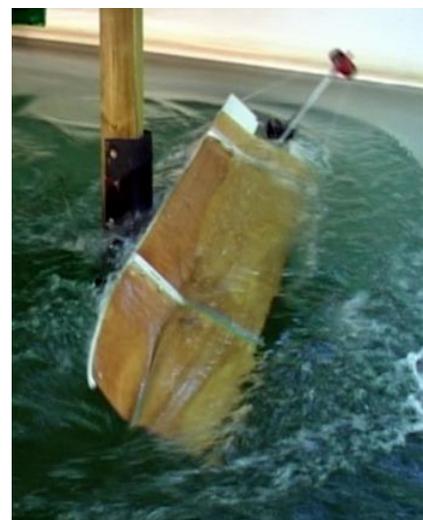
**Figure 19. Catamaran, 6 knots, 3.6 seconds after impact**
