# DEPLOYMENT OF LIFERAFTS FROM CAPSIZED OR SINKING VESSELS

Barry Deakin, Wolfson Unit for Marine Technology & Industrial Aerodynamics,  
University of Southampton, SO17 1BJ, UK.

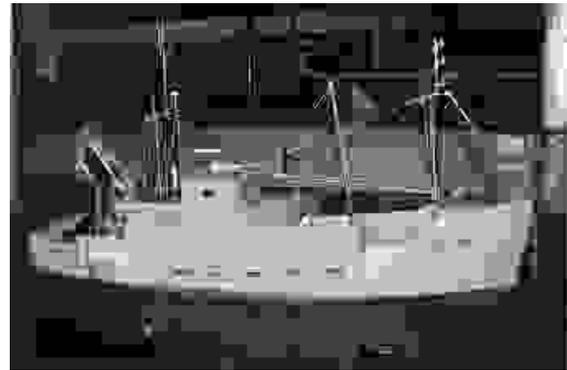
Figure 2. Westhaven model prepared for testing, with liferafts on the focsle and shelter.

The models incorporated watertight bulkheads, hatches, doors and vents in order that the flooding process, and therefore the sinking attitude, would be representative. The Westhaven model was ballasted to represent the estimated condition of the vessel prior to sinking, and the beam trawler was ballasted to a condition which just met the UK stability requirements.
